# **TOWN OF VICTORIA PARK REMNANT VEGETATION MANAGEMENT PLAN**

## **TOWN OF VICTORIA PARK**

**August 2004**

***Ecoscape (Australia) Pty Ltd***

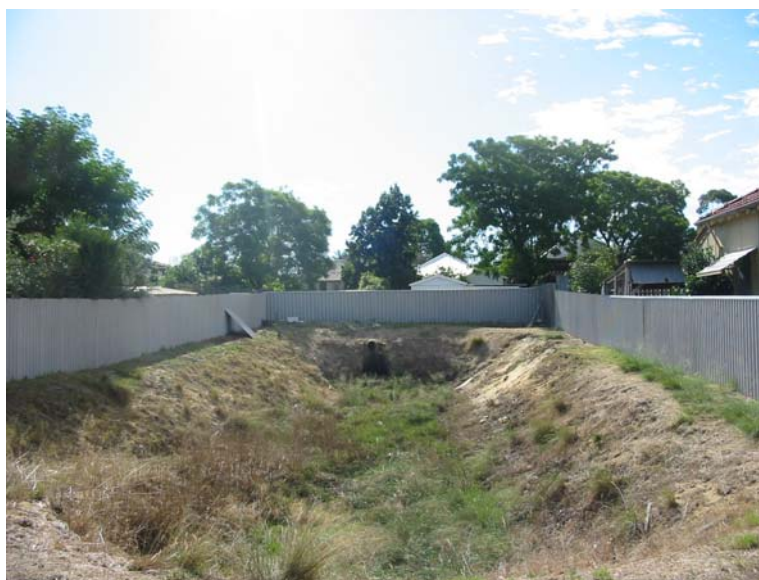
**Plate 1. A Sump with little aesthetic value - 39 Esperance Street**

Examples of a sump with little aesthetic value is shown in Plate 1 and a sump with aesthetic value is shown in Plate 2.

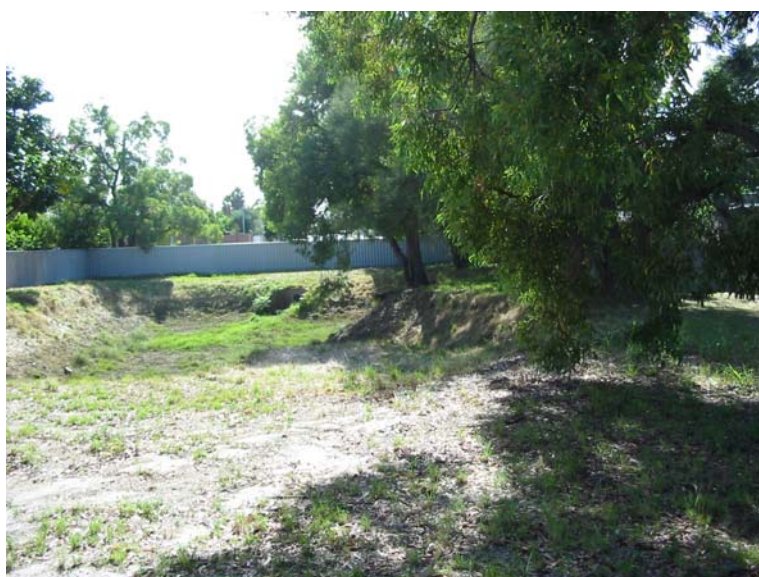
**Plate 2. A sump with aesthetic value - 30-32 Satellite Place**

- Multiple mature trees;
- Integration with surroundings (such as an adjacent park); and
- Structural diversity (i.e. shrubs and trees).

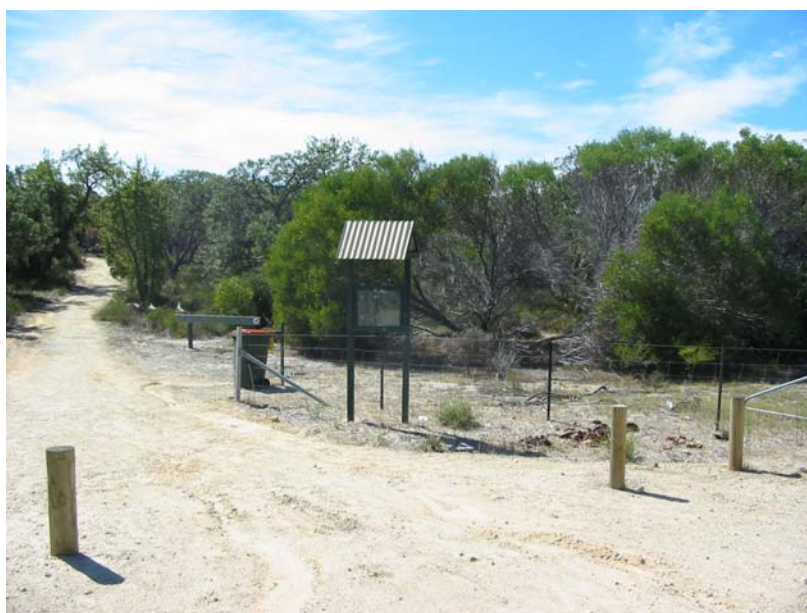
**Plate 3. The Baron-Hay Court entrance to Kensington Bushland Reserve**

The bollards visible in Plate 3 have been installed outside the fence, for the length of the reserve, along Baron-Hay Court.

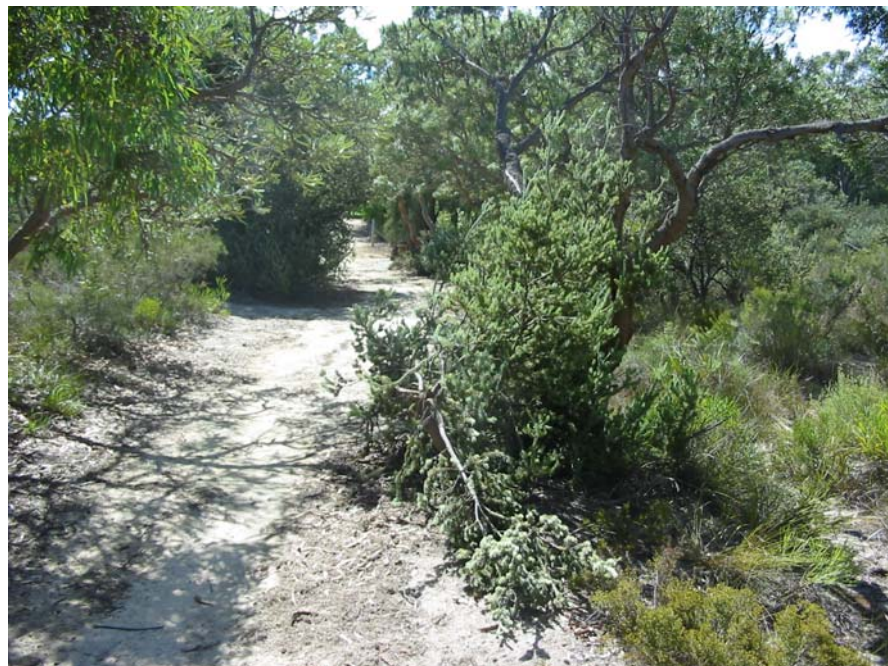
**Plate 4. Damage to an Unpruned Plant**

Access along some sections of paths has been obstructed by overhanging vegetation. This can discourage the use of formal paths, obstruct firefighting vehicles, and result in limbs being broken off plants by members of the public or management vehicles (an example of which is shown in Plate 4).

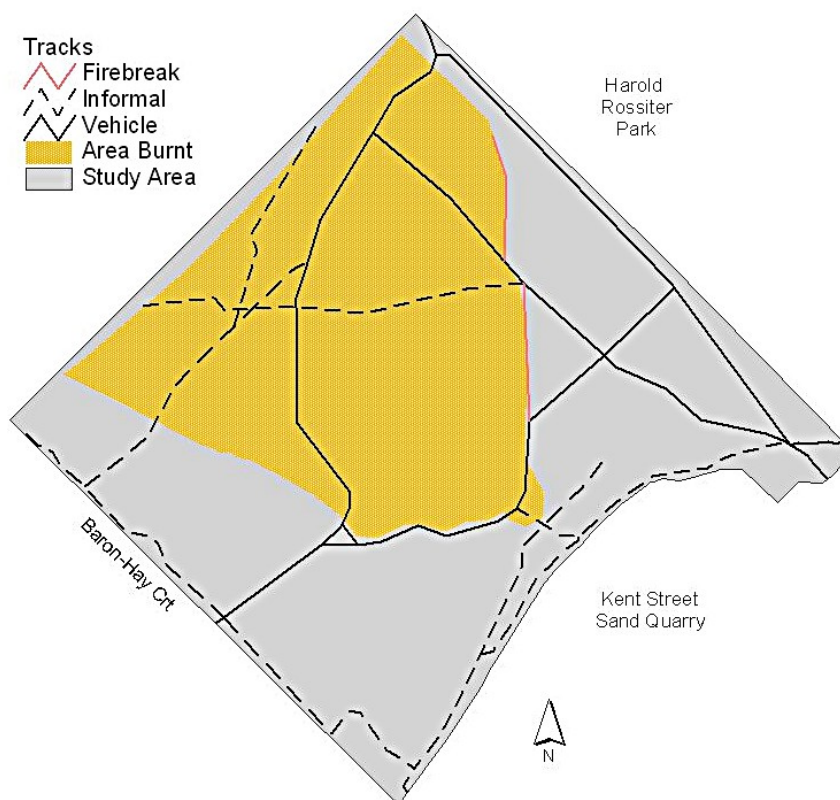
**Figure 6. The Extent of the February 2003 Fire**

Approximately 20% of the reserve was burnt in March 1993, the western quarter of the reserve was burnt in November 1999, and the reserve was burnt again in February 2003 (Friends of Kensington Bushland, 2003). The most recent fire in February burnt approximately 3.34 ha (31.5%) of the reserve (see Figure 6).

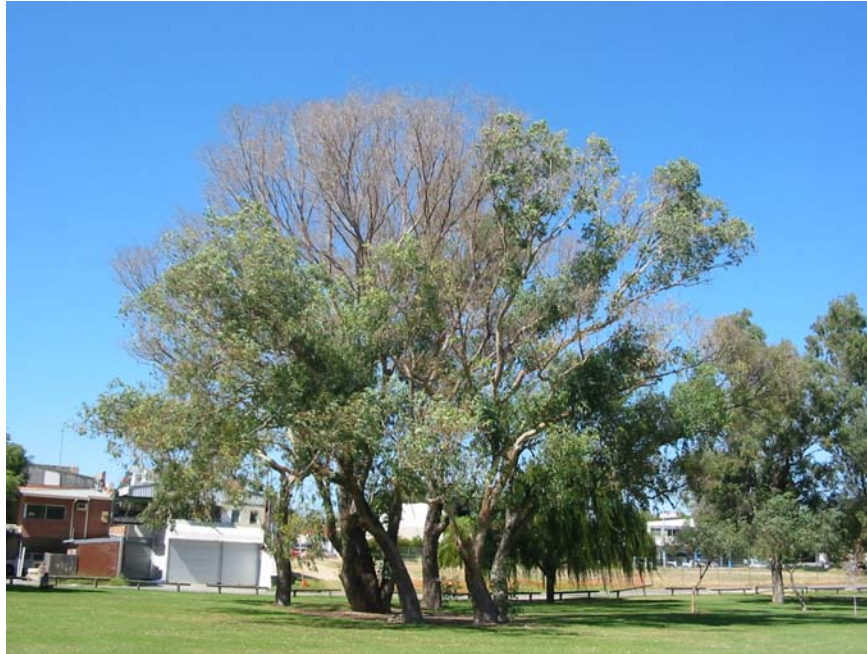
**Figure 12. Stressed Flooded Gum in Taylor Reserve**

The Swan River, Taylor Street, McCallum Lane and Ellam Street bound this reserve. Remnant indigenous vegetation in the parkland consists predominately of Flooded Gum (*Eucalyptus rudis*) with three native *Melaleuca* species (*M. cuticularis*, *M. raphiophylla*, *M. viminea*), and six Swamp Sheoaks (*Casuarina obesa*) on the riverbank. There are also a number of exotic species in the reserve. Some Flooded Gums appear stressed and this may be due to drought conditions over recent years. Figure 12 shows an example of tree stress.

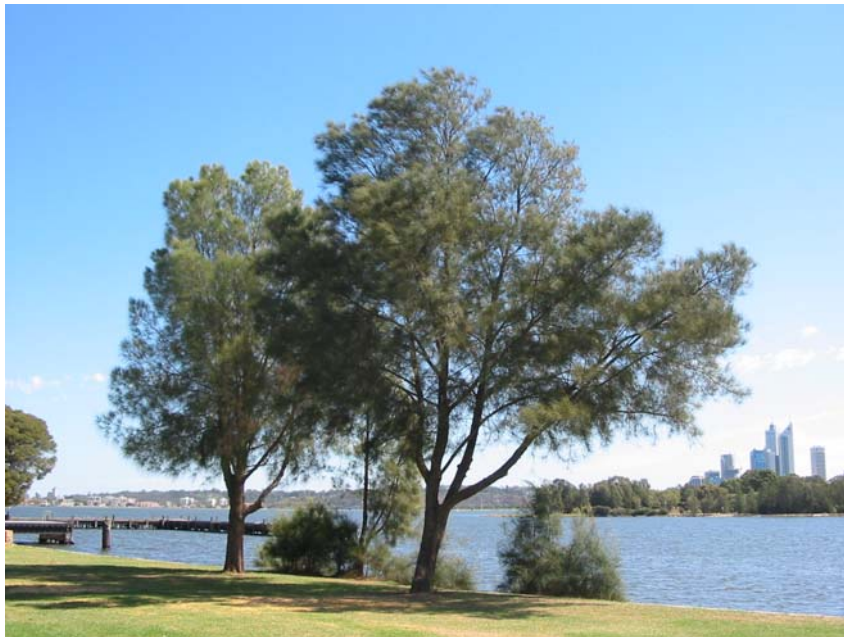
**Figure 13. Swamp Sheoak on the Swan River in Taylor Reserve, Victoria Park.**

There are further trees located towards Ellam Street. In this stand there is an overstorey of Flooded Gum with an understorey of *Melaleucas*. Closer to the river there are scattered Flooded Gums and occasional Paperbarks and Swamp Sheoaks.

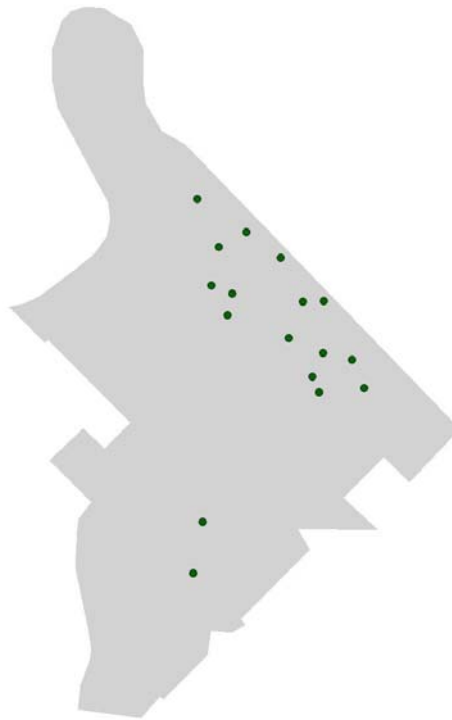
**Figure 15. Sumps with Indigenous Trees**

Of the 75 sumps, 17 support indigenous vegetation. These 17 are shown in Figure 15. Details of sumps without indigenous vegetation can be seen in Appendix Five.

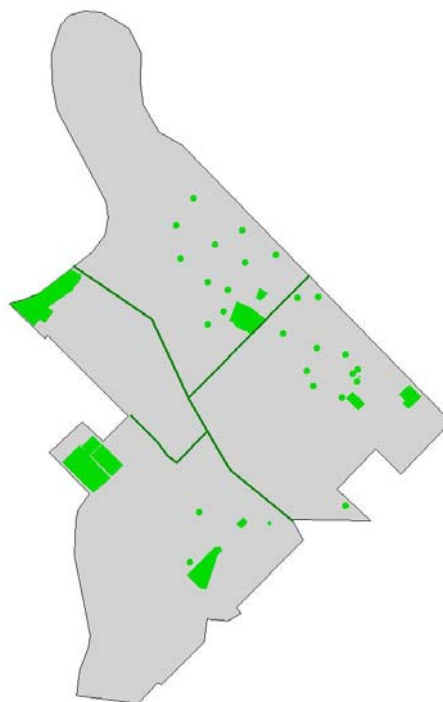
**Figure 16. Distribution of All Indigenous Vegetation, in Different Management Sectors**

The present distribution of indigenous vegetation is neither distributed equally across the municipality nor between the different classes of land use. The clustered distribution of sites is shown in Figure 16.

There is a concentration of sites in Carlisle and Lathlain, and paucity in Victoria Park. This concentration in Carlisle and Lathlain is largely due to the number of vegetated sumps in the area, as shown in Table 8.

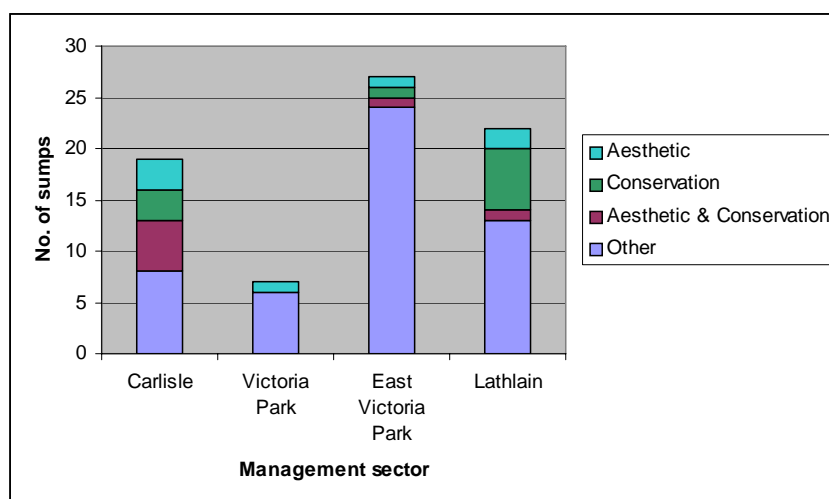
**Figure 20. The Values of Sumps in each Management Area**

Lathlain has the highest number of sumps with indigenous vegetation. Carlisle has the highest number of sumps with indigenous flora and aesthetic value, as well the highest number of sumps with aesthetic value but no indigenous flora. East Victoria Park has the greatest number of sumps with no vegetation. This pattern is very obvious in Figure 20.
